Bending Iron rebuild

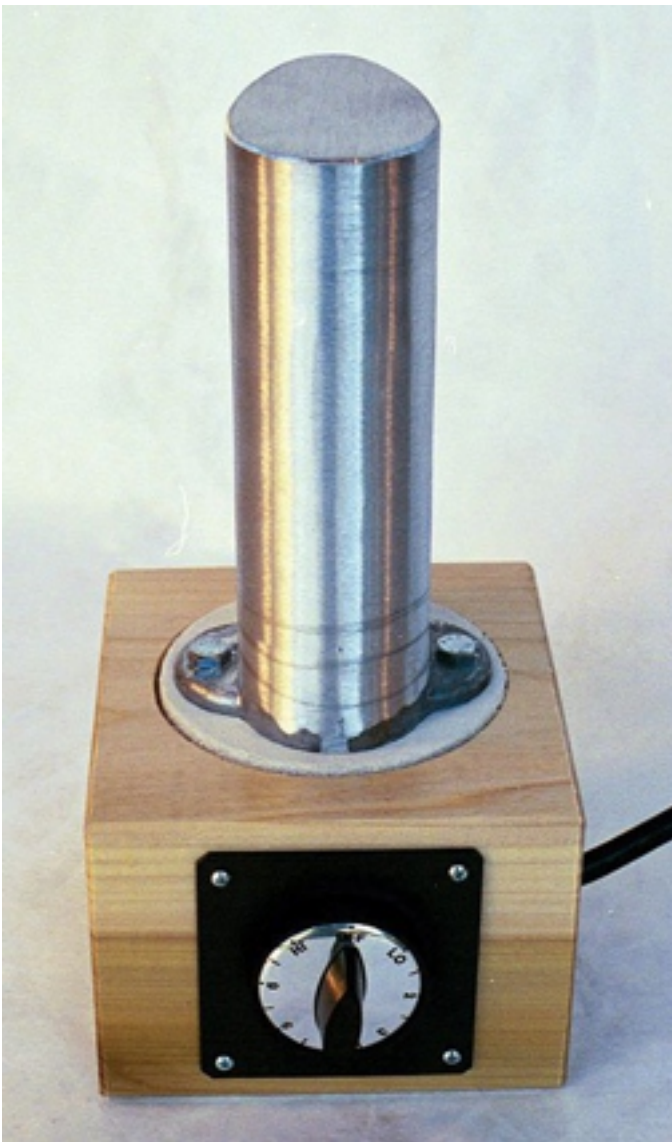
I bought the bender pictured here about 9 years ago, and have used it on average about once a week since then. After a couple of years the mounting bolts that hold the iron to the base began to loosen, so I tightened them. With time, the tightening became more frequent. It was then that I realized that the ceramic cloth between the iron and wooden base was breaking down and the wood underneath was becoming charred. I replaced the cloth, but with time the problem reoccurred, so I decided to rebuild it using a metal base.

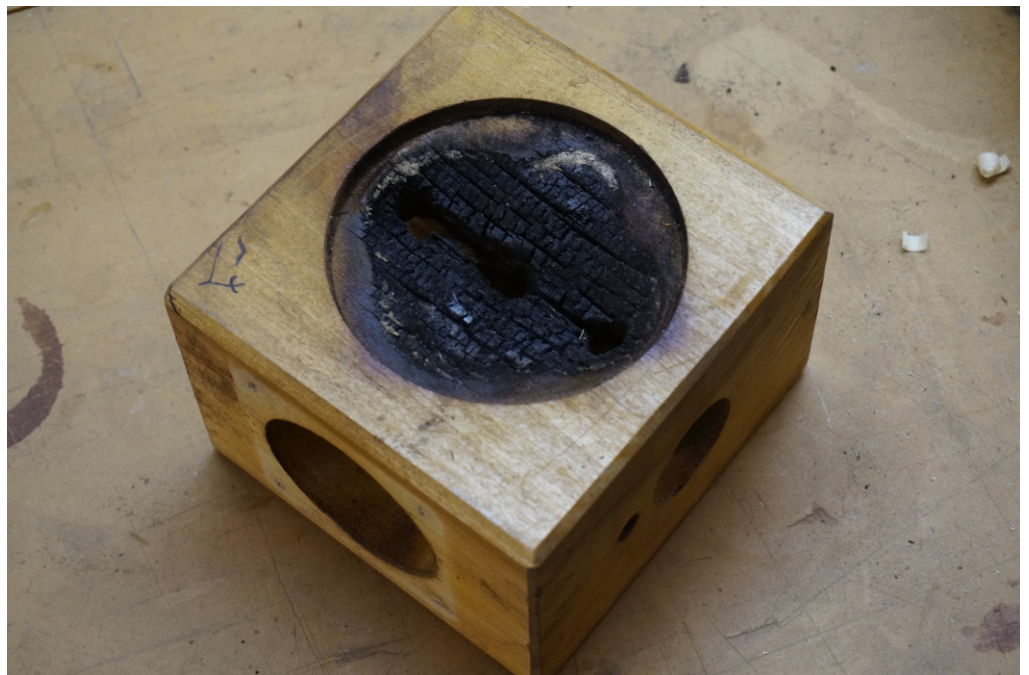
Here's the base after about 9 years of service. It was a possible fire hazard so I was always careful not to leave it plugged in and unattended, but kept on using it.

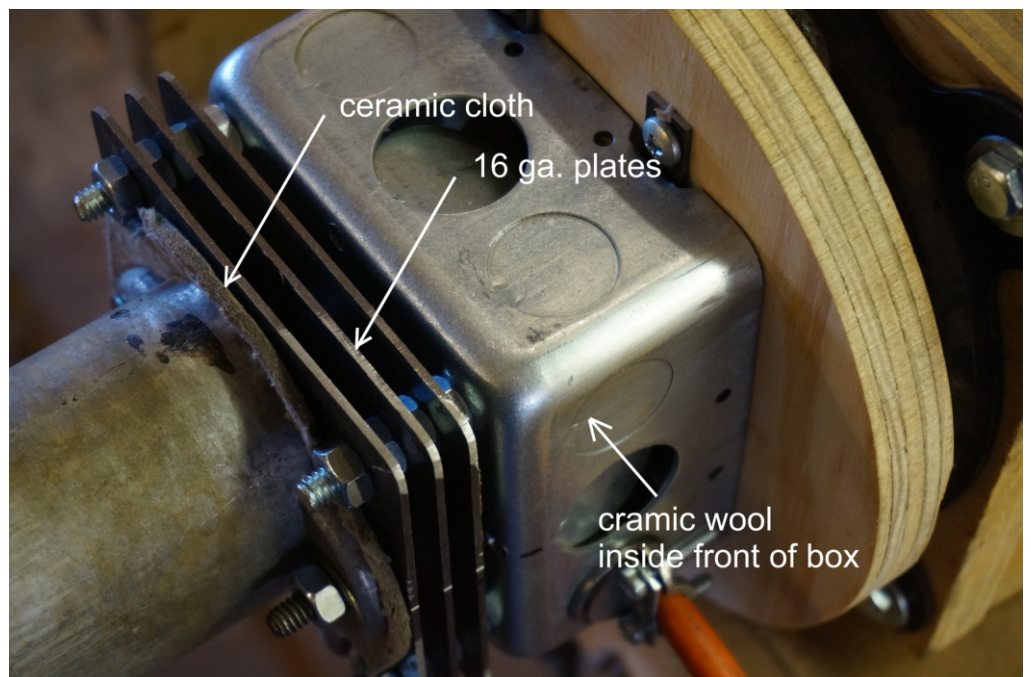
The iron is mounted on a deep electrical box with steel fins in between to dissipate the heat. There is also 1/8" thick ceramic cloth between the iron and first plate, and 3/4" of ceramic wool between the inside front of the box and the wiring. In use, the box proved cool enough to grab and rotate to new positions
